# TECHNICAL SERVICE NOTICE

Wiring Harness 121569 or 132017  
Notice No: 129479xA

Products Affected:  
New Way Sidewinder Automated

Updated: October 11, 2019

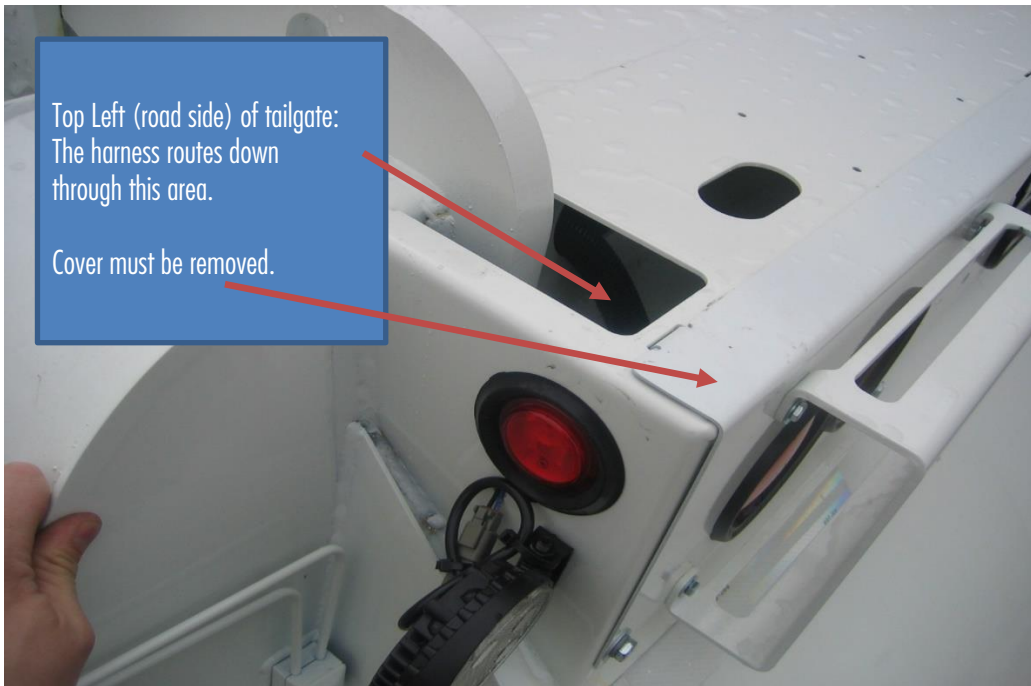
We are communicating a potential performance issue with the tailgate lights on the New Way Sidewinder Automated (ASL) refuse packer. Specifically, we are addressing the performance of the wiring harness 121569 or harness 132107, which runs from the tailgate top cover sheet lights to the lower lights on the tailgate.

These harnesses are prone to chafing near the top of the tailgate on the roadside (LH side). If you find this issue we recommend the harness be replaced with a new rev harness that has a protective loom over this area.
